THE BUSINESS CASE FOR AN ACCESSIBLE EVERGREEN

MOREHEAD-CAIN ACCESSIBILITY TEAM
July 2019

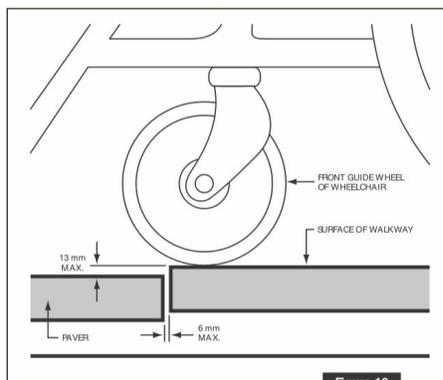
Figure 12

1. Unit paving materials used in sidewalks, paths and walkways should be firm and level, with joints no greater than 6 mm wide.
 - a. (AODA Guidelines, Page 8)

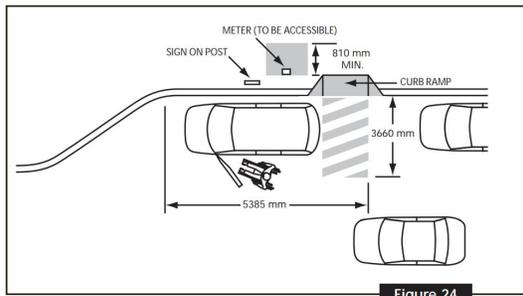
Figure 24

- a. (AODA Guidelines, Page 14)
5. At least one accessible parking space for wheelchair vans, a minimum of 3660 mm wide and 5385 mm long, should be provided for each 100 spaces. (See Figure 24)

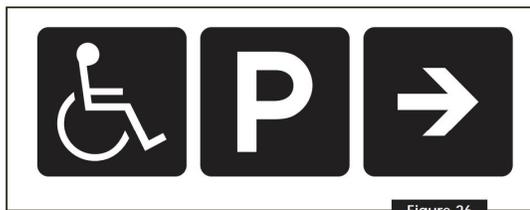
Figure 26

1. Parking meters to be accessible for persons with disabilities.
 - a. (AODA Guidelines, Page 14)
2. All accessible parking spaces should be marked with the “International Symbol of Accessibility”, (e.g., with a paving sign and a post mounted sign). (See Figures 26 and 27)

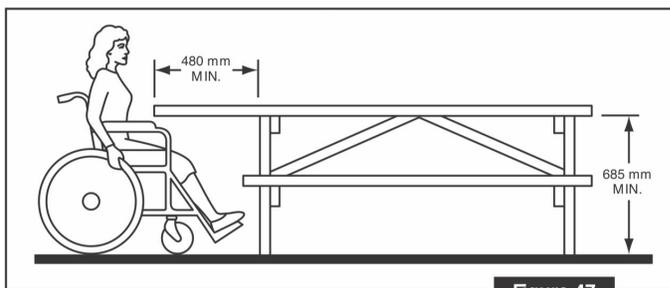
Figure 47

1. The design of picnic tables should allow persons using mobility aids to approach them from one or both ends and provide adequate knee and armrest clearance. (See Figures 47, 48 and 49)

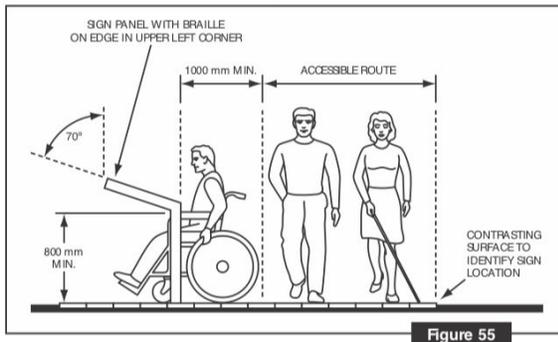
- a. (AODA Guidelines, Page 29)
- 2. Where special lookout locations or wildlife viewing areas are included, ensure that clear signage is provided nearby (e.g.: on the trail or path).
 - a. (AODA Guidelines, Page 29)
- 3. Where possible, provide a tactile map (e.g., map with a raised outline) of all trails and features at the start of the trail and periodically along the trail to benefit persons who have visual limitations. (See Figure 55)
 - a. (AODA Guidelines, Page 29)

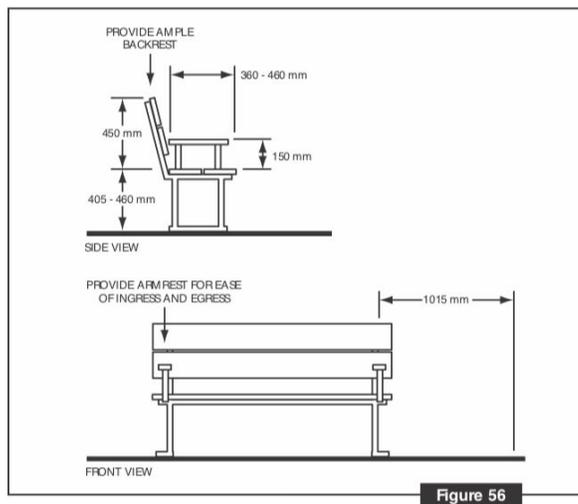
- 1. Fixed benches should include suitable back supports and arms to allow for easy transfers, with a seat height between 405 mm and 460 mm. (See Figure 56)
 - a. (AODA Guidelines, Page 30)

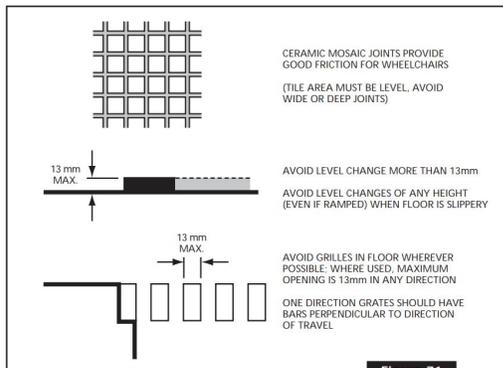
- 1. Figure 71: Avoid grilles in floor wherever possible; where used, maximum opening is 13mm in any direction. One direction grates should have bars perpendicular to direction of travel.
 - a. (AODA Guidelines, Page 40)

1.6.1 Colour and Texture	<ul style="list-style-type: none"> ● 1.6.1. Figure 71 Grates are parallel to the direction of travel rather than perpendicular. The width of single grate is too wide (25.4 mm) compared to the required 13 mm 	Sidewalk outside of Evergreen Garden Market

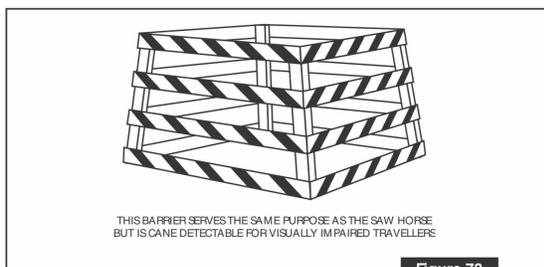
Figure 73

1. Cane detectable temporary barriers should be provided around all short-term repair sites (e.g. sidewalk repairs, manhole access covers etc.), as an aid to persons who have visual limitations. (See Figure 73)
 - a. (AODA Guidelines, Page 41)

1.6.2 Construction Site Protection	<ul style="list-style-type: none"> ● 1.6.2.4 The boundaries between construction sites and pedestrian traffic are unclear and lack cane detectable temporary barriers. <ul style="list-style-type: none"> ○ The site may be hazardous to those with visual limitations 	Construction at the north end of The Pavilions

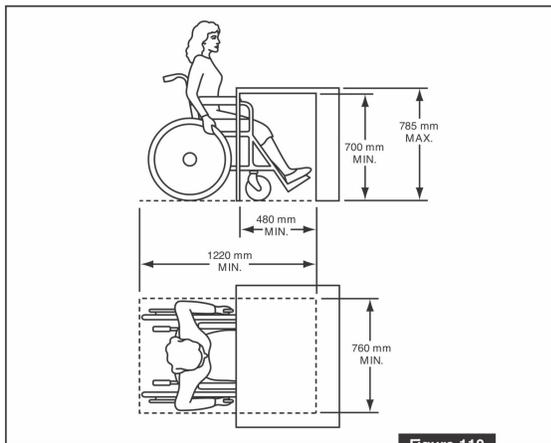
1. Coffee and telephone tables, located in waiting areas and lounges, should be no lower than 510 mm high and they should have an open base to ensure persons using mobility aids approach
 - a. (AODA Guidelines, Page 66)
2. Some seats should be provided with both armrests and backrests to provide adequate support for frail individuals, seniors or persons with stability and/or transferring difficulties.
 - a. (AODA Guidelines, Page 66)
3. Loose seating, chairs or benches should have seat heights between 405 m and 460 mm, so that seniors or others can get in and out of them without difficulty.
 - a. (AODA Guidelines, Page 66)
4. Tables and desks should generally be selected with a working surface no higher than 785 mm and clear knee space of 700 mm high, by at least 760 mm wide between supports, to allow easy wheelchair access and use. (See Figure 110)
 - a. (AODA Guidelines, Page 66)

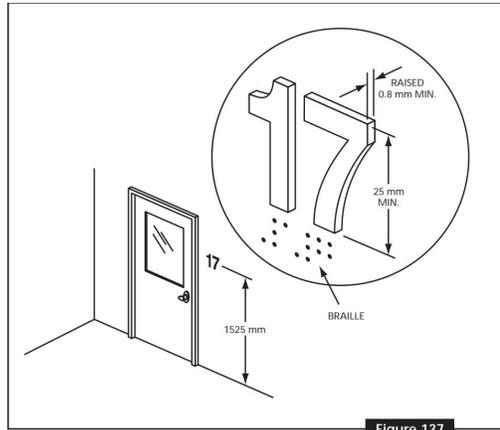
Figure 137

1. For Braille users, braille information should be located immediately below all room numbers and names, as well as below any major directional signs. (See Figures 137 and 142)

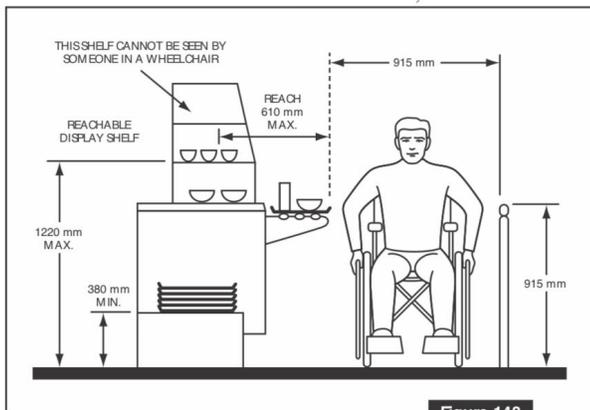
Figure 148

1. Where counter service is provided, at least one section of the counter should be no higher than 915 mm by 760 mm wide, to allow a person using a wheelchair or scooter to approach. (See Figure 148)
 - a. (AODA Guidelines, Page 90)
